**Parts and Material Analysis Report**

Customer	Global Components	Part Number	TPS54061DRBR	
<b>Customer PO</b>	Q2201040013	Manufacturer	Texas Instruments	
<b>Customer Address</b>	2479 Rue Guénette, Montréal, Quebec H4R 2E9 CANADA	Date/Lot Code	2129/2138	
Report Date	2/8/2022 2:26:02 PM	Quantity Revd	total: 21000 test: 21000	
Revision	0	AAA WO#	W2201130000

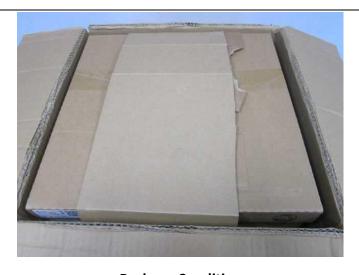
**Package Condition**

Devices were received in acceptable condition.

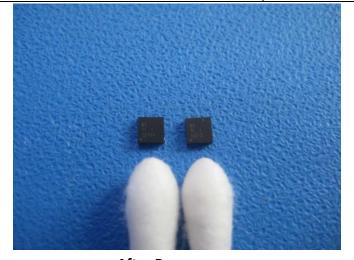
**After Acetone**

Acetone Test results for resurfacing were negative - no residue was deposited on the swab.

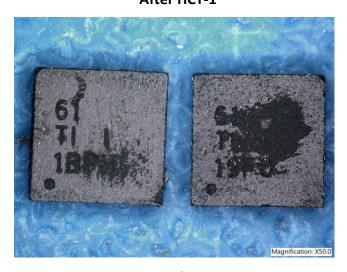
**HCT-2 Close up**

HCT-2 Test results for resurfacing were positive - minor residue was deposited on the swab. No sanding or previous markings revealed.

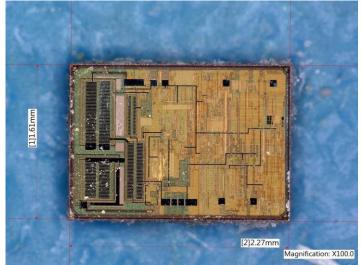
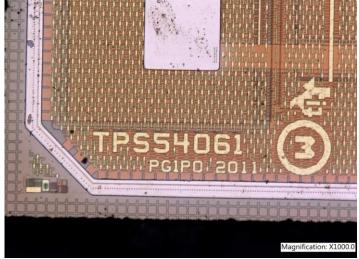
Internal Visual Inspection on 2 samples marked with D/C: 21+ revealed Manufacturer TI marking with 2011 copyright year and die marking TPS54061 and PG1P0. Device confirmed to be a Texas Instruments die.

Die Topography - D/C 2129

Die Markings - D/C 2129

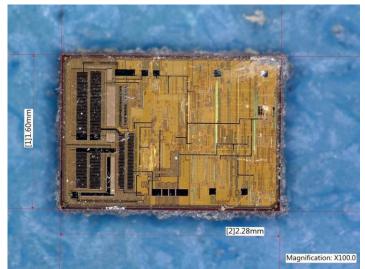
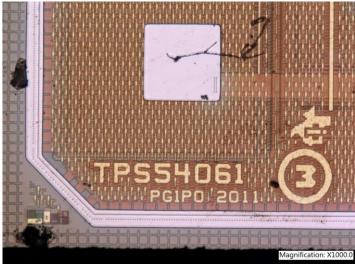
Die Topography - D/C 2138

Die Markings - D/C 2138

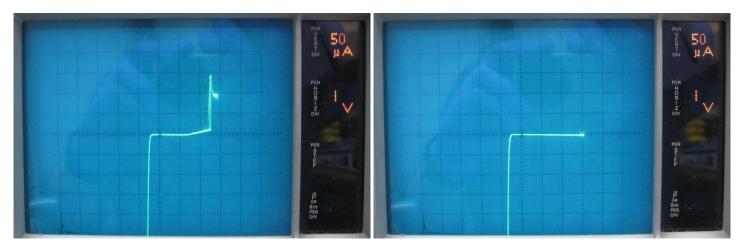
Passing I-V Curve - PIN 2 (VIN) to PIN 7 (GND)

Passing I-V Curve - PIN 3 (EN) to PIN 7 (GND)

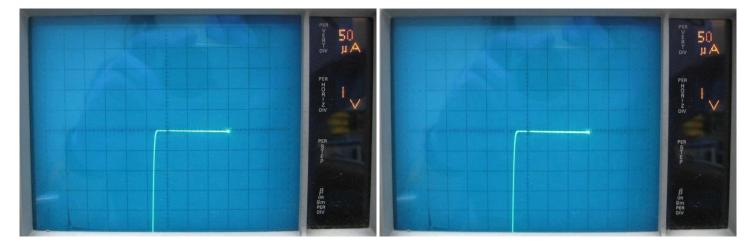
Passing I-V Curve - PIN 4 (RT/CLK) to PIN 7 (GND)

Passing I-V Curve - PIN 5 (VSENSE) to PIN 7 (GND)

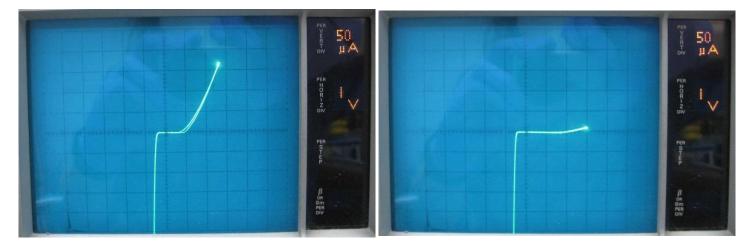
Passing I-V Curve - PIN 6 (COMP) to PIN 7 (GND)

Passing I-V Curve - PIN 8 (PH) to PIN 7 (GND)
